PREPARED	NAME L. Pazmany	Mar. 7-73	PAZMANY AIRCRAFT CORPORATION — SAN DIEGO — CALIFORNIA —	MODEL NO.	PL-4A
CHECKED			ENGINEERING CHANGE NOTICE #1	REPORT NO.	
APPROVED				PAGE NO.	1

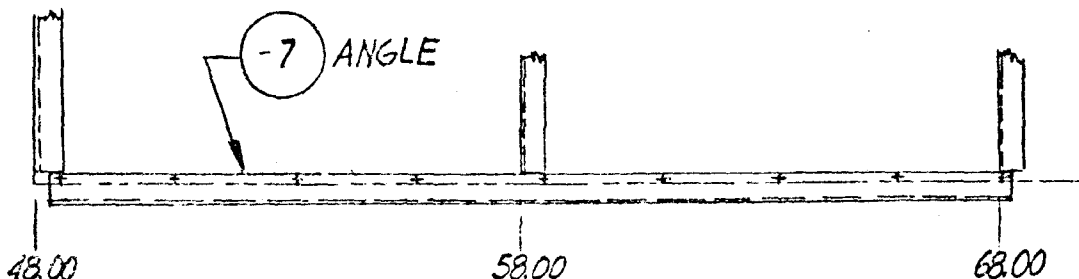
DWG 4-10-001 - WING ASSEMBLY - (OPTIONAL CHANGE)

DURING FLIGHT TESTING IT WAS FOUND THAT THE LEFT WING DROPPED FIRST CONSISTENTLY. THIS COULD BE A RESULT OF A MISALIGNMENT OF THE WINGS. THIS TENDENCY WAS CORRECTED BY ADDING ANOTHER STALL STRIP IN EACH WING PANEL AS SHOWN ABOVE. THIS COULD BE A PARTICULAR SITUATION WITH THE PROTOTYPE ONLY, AND MAY NOT BE REQUIRED IN YOUR AIRPLANE. IF YOU FIND THE SAME SITUATION IN YOUR AIRPLANE, INSTALL STALL STRIPS AS SHOWN ABOVE BUT ONLY TAPPED TO BEGIN. RIVET STALL STRIPS IF IT HELPED.

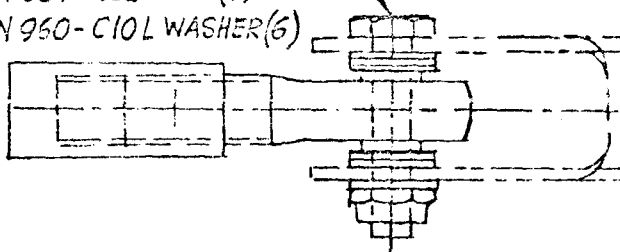
DWG 4-50-003 - AILERON CONTROL INSTALL.

NAS 1103-12 BOLT (1) (MANDATORY CHANGE)
AN 364-1022 NUT (1) TO CORRECT ERROR
AN 950-C10L WASHER (6)

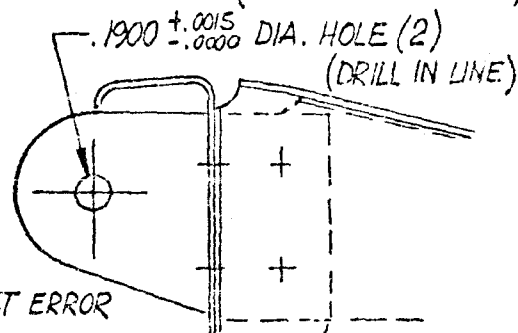
DWG. 4-10-004 - AILERON - (MANDATORY CHANGE)

TO CORRECT ERROR

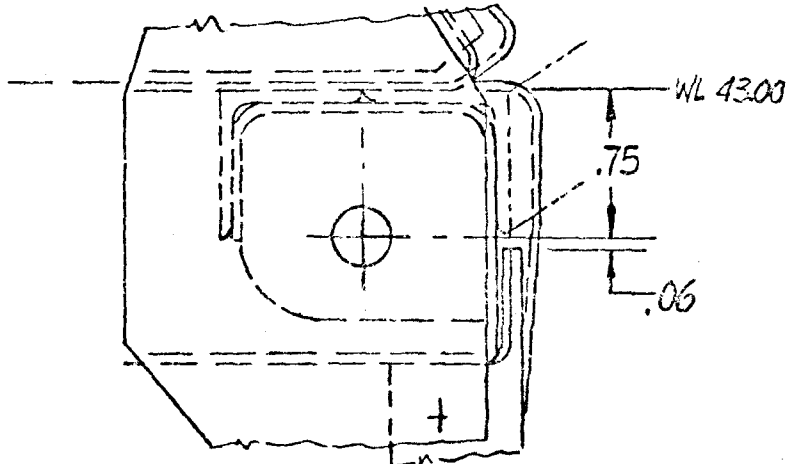
DWG. 4-30-002 - FIREWALL ASSEMBLY.

(MANDATORY CHANGE) - TO CORRECT ERROR DRAWING WAS OUT OF SCALE. LOCATION OF HOLE FOR ENGINE MOUNT BOLT WAS SHOW AT .67 BELOW WL 43.00. ALSO CORRECT LOCATION OF THIS HOLE IN DETAIL OF -31 GUSSET

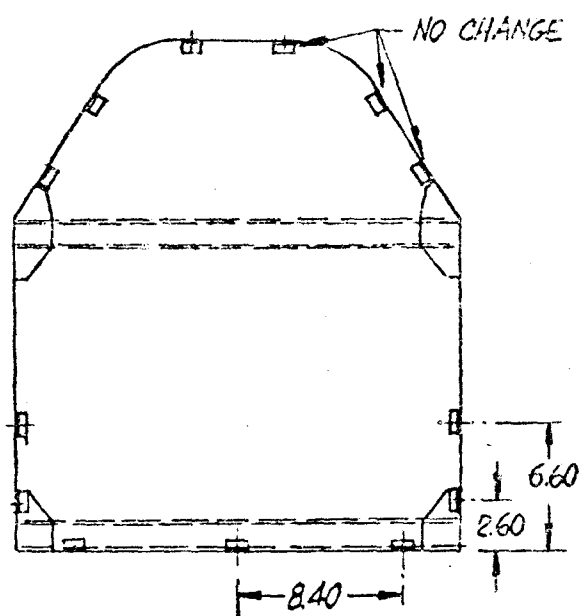
DWG. 4-30-002 - FIREWALL ASSEMBLY

(MANDATORY CHANGE) - TO CORRECT ERROR.

THE LOCATION OF -19 ANGLES WAS CHANGED AT THE TIME OF INSTALLING THE COWL. THIS CHANGE WAS NOT INCORPORATED IN THE FIREWALL DWG. THE ANGLES -19 AND THE CAMLOC RECEPTACLES FOR THE UPPER COWL ARE NOT CHANGED. THE ANGLES -19 FOR THE BOTTOM COWL ARE RELOCATED AS SHOWN. USE NAS 697-A08K NUTPLATES (7 PLACES) INSTEAD OF CAMLOCKS FOR THE BOTTOM COWL.
