PREPARED	NAME L. Pazmany	Mar. 7-73	PAZMANY AIRCRAFT CORPORATION — SAN DIEGO — CALIFORNIA —	MODEL NO.	PL-4A
CHECKED			ENGINEERING CHANGE NOTICE #1	REPORT NO.	
APPROVED				PAGE NO.	1

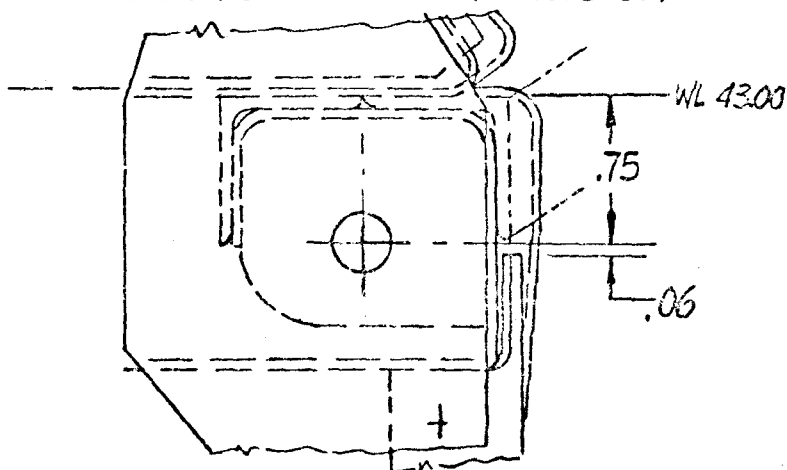
DWG. 4-30-002 - FIREWALL ASSEMBLY.

(MANDATORY CHANGE) - TO CORRECT ERROR DRAWING WAS OUT OF SCALE. LOCATION OF HOLE FOR ENGINE MOUNT BOLT WAS SHOW AT .67 BELOW WL 43.00. ALSO CORRECT LOCATION OF THIS HOLE IN DETAIL OF -31 GUSSET

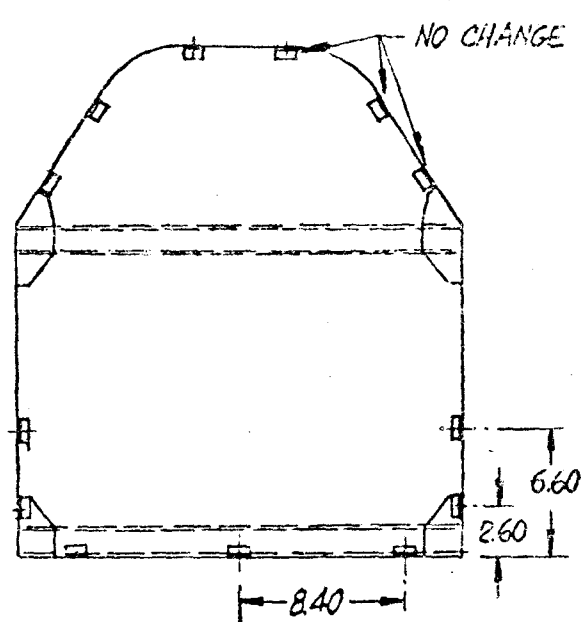
DWG. 4-30-002 - FIREWALL ASSEMBLY

(MANDATORY CHANGE) - TO CORRECT ERROR.

THE LOCATION OF -19 ANGLES WAS CHANGED AT THE TIME OF INSTALLING THE COWL. THIS CHANGE WAS NOT INCORPORATED IN THE FIREWALL DWG. THE ANGLES -19 AND THE CAMLOC RECEPTACLES FOR THE UPPER COWL ARE NOT CHANGED. THE ANGLES -19 FOR THE BOTTOM COWL ARE RELOCATED AS SHOWN. USE NAS 697-A08K NUTPLATES (7 PLACES) INSTEAD OF CAMLOCKS FOR THE BOTTOM COWL.
