PAZMANY NEWSLETTER
NUMBER 72
SPRING, 1985
Aircraft Designer:
Ladislao Pazmany
PO Box 80051
San Diego, CA 92138

NEWS FROM PAZ: I have the unfortunate duty to report on one bit of tragic news, that of the first fatal accident in any of Paz's designs. News seems to travel slowly sometimes, as this occurred way back on June 5, 1983. Paz was kind enough to send me a copy of the accident report and accompanying letter, which he suggested I include in this newsletter - see the following few pages. In summary, it was pointed out in the report that the fuselage sides bowed out upon impact, causing the seat back/shoulder harness attach cross member to pull loose and allow the occupants to move forward. However, I do want to emphasize one point mentioned in the report: Please note that in the next to last paragraph the investigator mentions that "this particular accident was thought to have been non-survivable" in any case. Of course, one will never know, but it seems questionable that the occupants could have survived even if the cross member had remained in place. See the following three pages:

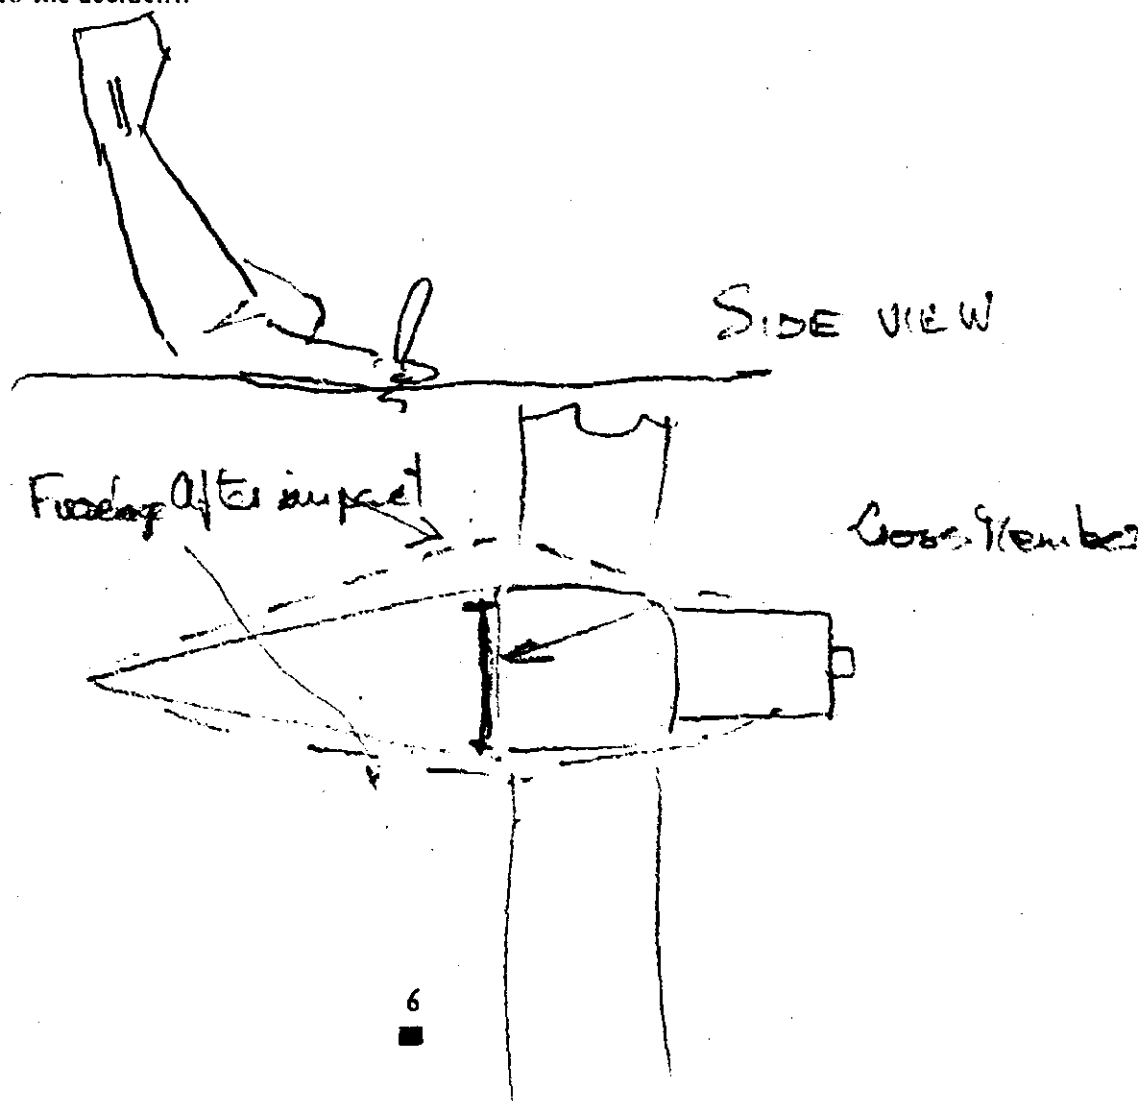
The upper torso restraint for both occupants was secured by very strong attachments to a cross-member riveted to the fuselage. Upon impact, the four rivets securing each end of the cross-member failed and, although this particular accident was thought to have been non-survivable, both occupants received severe head injuries consistent with 'jack-knifing'.

In the next to last paragraph you will see a note concerning the rivets attaching the shoulder harness. I examined these rivets carefully and feel that the AIB could have been a little more explicit. The rivets in fact failed in tension due to the action of the fuselage breaking up on impact. The mode of failure was that the aircraft hit the ground very nose down and this in turn caused the upper longerons to buckle under compression loads. The cross member in the fuselage was then in tension due to the buckling in the fuselage and allowed these rivets to fail in tension due to the fuselage which had already been substantially damaged bursting outwards.

I have put a small sketch at the end to illustrate the effect.
