PAZMANY NEWSLETTER  
NUMBER 80  
3rd QUARTER, 1987  
Aircraft Designer:  
Ladislao Pazmany  
PO Box 80051  
San Diego, CA 92138

Another of those "if I'd had room I'd have put it in a long time ago" features for this newsletter is a copy of the article from the March, 1987 issue of EAA's *Sport Aviation* on Ed Boothe's recently completed PL-2 with wet wing tanks. I intended to include this article a while back, but better late than never. I realize that not all of you are EAA members, especially some of you who are building / flying your PLs overseas, so this may be your first opportunity to see this information. If you want to try this on your own PL, Ed included all the facts and figures in the article. I really enjoyed seeing all the pictures, particularly the "after" pics: Removing those tip tanks sure changes the lines of the PL! See the next three pages for the article - and check out the March '87 issue if you'd like color pictures.

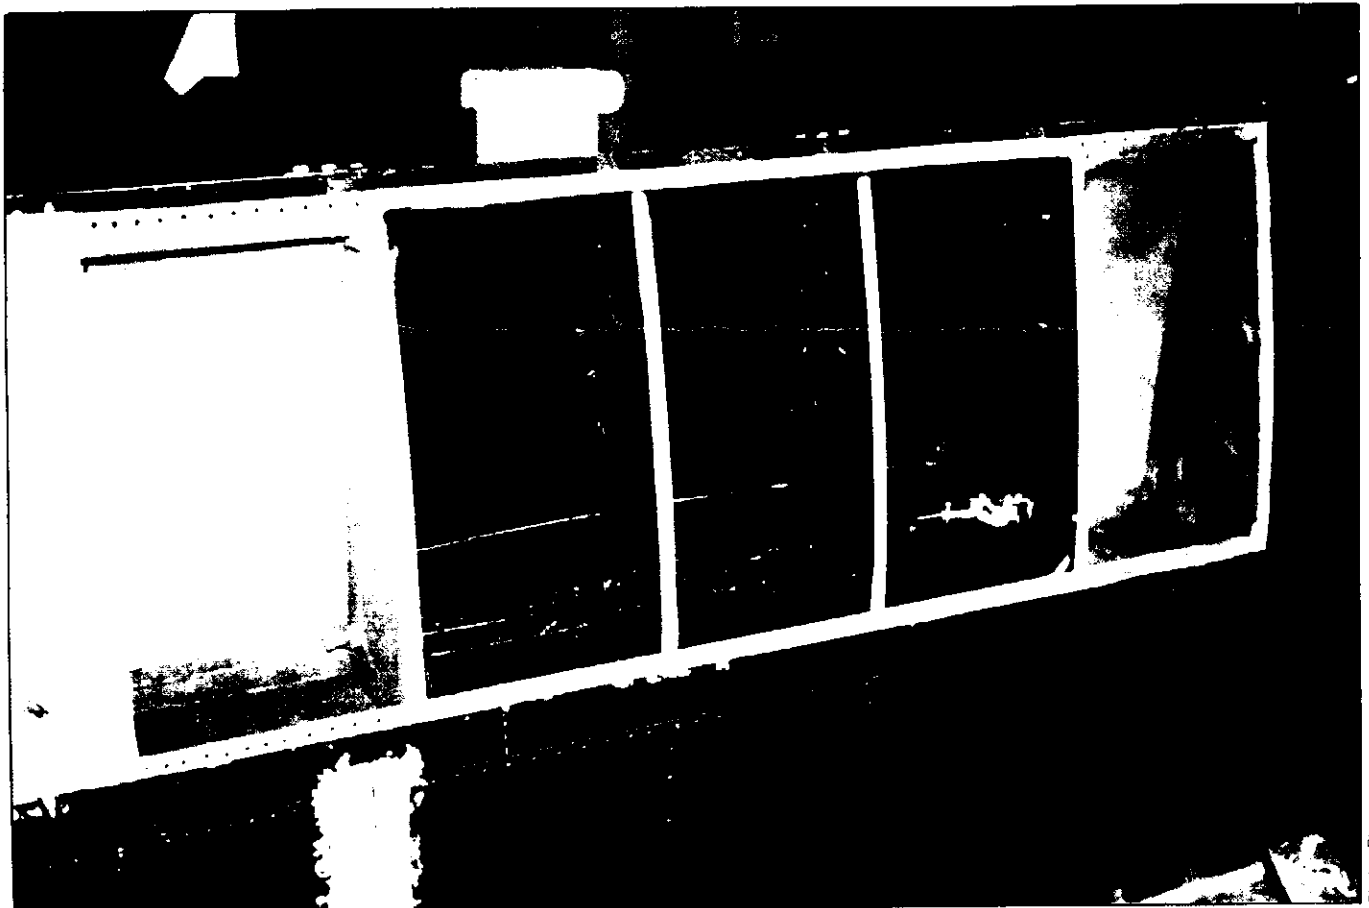
Three rib bays sealed off and plumbed to serve as a 14 gallon fuel tank.

The fuel capacity of the new tanks was 14 gallons each which increased the total fuel capacity by three gallons.
